Devil's Lake

Lake Management Plan Update 2017

PLM Lake & Land Management Corp.

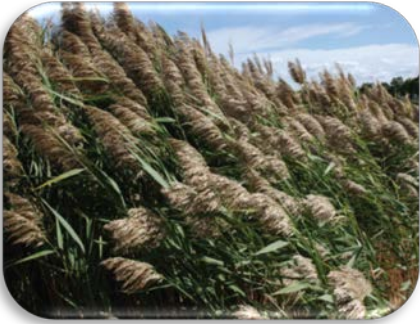
- The invasive terrestrial plants, Purple loosestrife and Phragmites should be controlled along the shoreline and adjacent wetlands where present. Both species are exotic and have the ability to displace beneficial native vegetation. Purple loosestrife grows 2 -4 feet tall and is a vibrant magenta color. It is very aggressive and can quickly become the dominant wetland vegetation. Phragmites (common reed) is a wetland grass that ranges in height from 6 to 15 feet tall. "Phrag" quickly becomes the dominant feature in aquatic ecosystems, aggressively invading shorelines, wetlands, and ditches. This plant creates dense "strands" - walls of weeds crowding out beneficial native wetland vegetation and indigenous waterfowl habitats. Spreading by fragmentation and an extensive root system, Phragmites ultimately out-competes native plant life for sun, water and nutrients.

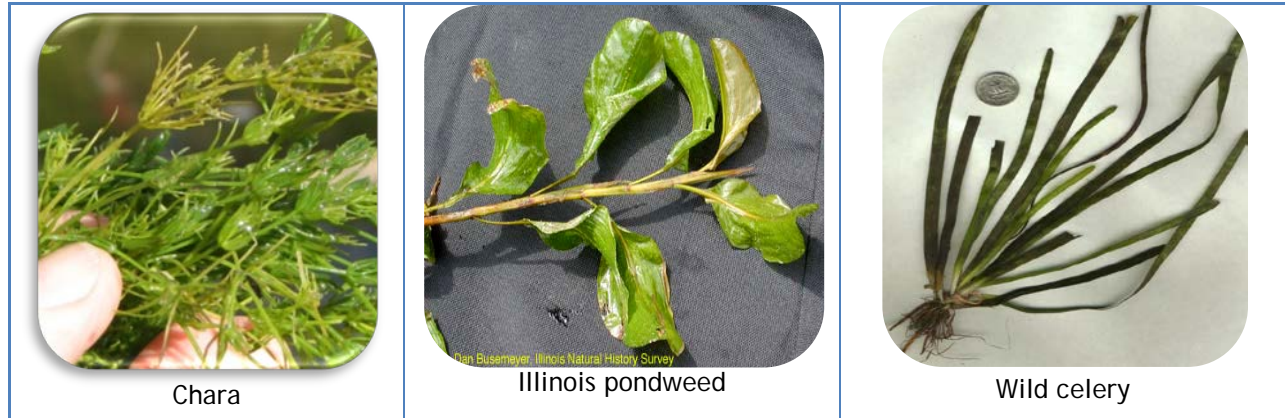
The native plant species in Devil's Lake benefit the lake, performing such functions as stabilizing sediments and providing habitat for fish and other aquatic organisms. In general, native species cause few problems, compared with those caused by exotic plants. Three species commonly found in higher densities on Devil's Lake are Chara, Illinois pondweed and Wild celery.

Chara

Illinois pondweed

Wild celery

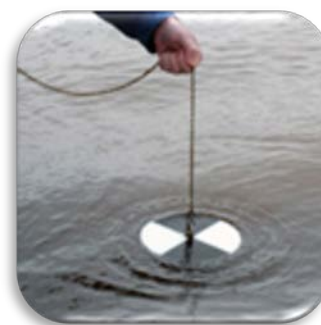
The Secchi disk depth is a measure of water clarity, determined by measuring the depth to which a black and white disk can be seen from the surface. (Larger numbers represent greater water clarity.) In June, the Secchi disk depth was 4 meters. The September Secchi disk depth was constant at 4 meters.
