# Devil's Lake

## Lake Management Plan Update 2018

### **PLM Lake & Land Management Corp.**

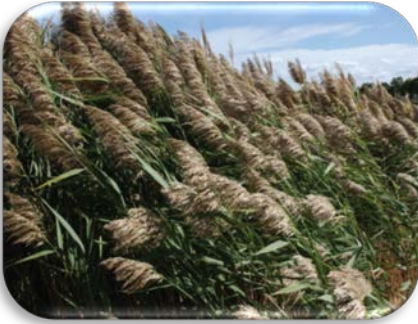
- The invasive terrestrial plants, Purple loosestrife and Phragmites should be controlled along the shoreline and adjacent wetlands where present. Both species are exotic and have the ability to displace beneficial native vegetation. Purple loosestrife grows 2 -4 feet tall and is a vibrant magenta color. It is very aggressive and can quickly become the dominant wetland vegetation. Phragmites (common reed) is a wetland grass that ranges in height from 6 to 15 feet tall. "Phrag" quickly becomes the dominant feature in aquatic ecosystems, aggressively invading shorelines, wetlands, and ditches. This plant creates dense "strands" - walls of weeds crowding out beneficial native wetland vegetation and indigenous waterfowl habitats. Spreading by fragmentation and an extensive root system, Phragmites ultimately out-competes native plant life for sun, water and nutrients.

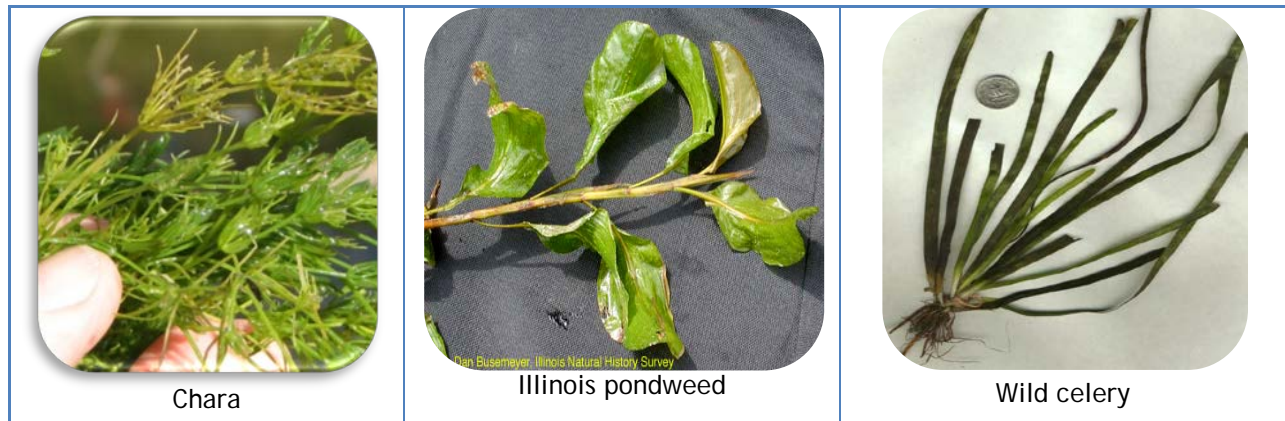
The native plant species in Devil's Lake benefit the lake, performing such functions as stabilizing sediments and providing habitat for fish and other aquatic organisms. In general, native species cause few problems, compared with those caused by exotic plants. Three species commonly found in higher densities on Devil's Lake are Chara, Illinois pondweed and Wild celery.

Chara

Illinois pondweed

Wild celery

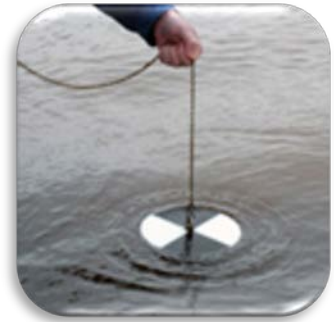
The Secchi disk depth is a measure of water clarity, determined by measuring the depth to which a black and white disk can be seen from the surface. (Larger numbers represent greater water clarity.) In April, the Secchi disk depth was 3.5 meters. The August Secchi disk depth was constant at 3.5 meters.
